CASE STUDY #3

Commercial Office Building Jersey City, NJ

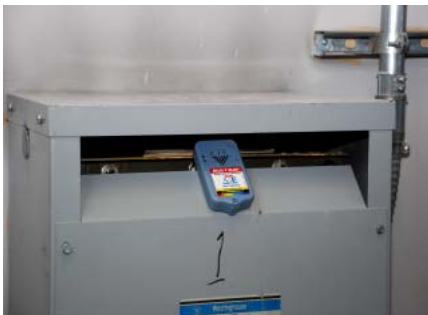
Location	MCC-Panel	Equipment ID	Equipment Type	Enclosure Temp	Delta T	Reported	Status
1st Floor E. C.	N/A	DS-1A	Fused Disconnect	80.2	8.4	05/05 10:08	OK
1st Floor E. C.	N/A	DS-1C	Disconnect	73.39999	0.7	05/05 10:02	OK
1st Floor E. C.	N/A	PP-1A	Power Panel	74.3	2.5	05/05 10:06	OK
1st Floor E. C.	N/A	PP-1A	Power Panel	80.1	0	04/20 07:32	NoResponse
1st Floor E.C.	N/A	T-EMLTG	T/F-150	195.3	0	05/05 10:14	CRITICAL
2nd Floor E. C.	N/A	DS-2A	Fused Disconnect	74.8	7.2	05/05 10:03	OK
2nd Floor E. C.	N/A	DS-2B	Disconnect	73	5.4	05/05 10:10	OK
2nd Floor E. C.	N/A	DP-2A	Distribution Panel	70.9	1.1	05/05 10:16	OK
3rd Floor E. C.	N/A	DS-3A	Disconnect	71.6	1.6	05/05 10:08	OK
3rd Floor E. C.	N/A	DS-3B	Disconnect	73	2.8	05/05 10:13	OK
3rd Floor E. C.	N/A	DP-3A	Distribution Panel	72.89999	2.7	05/05 10:16	Low Battery

Transformer T-EMLTG showing an enclosure temp. of 195.3 degrees F.

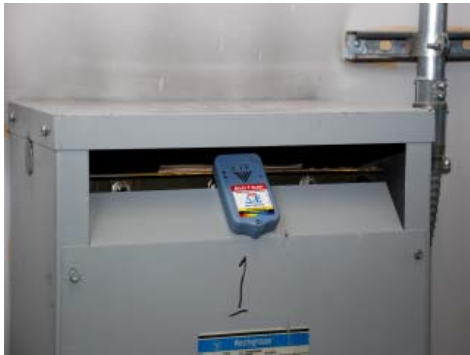
Figure #3

The Delta T Alert was magnetically installed on the vent of this particular transformer.
